Situation Photo Log

Tuesday, October 23, 2012

Kalamazoo River / Enbridge Spill

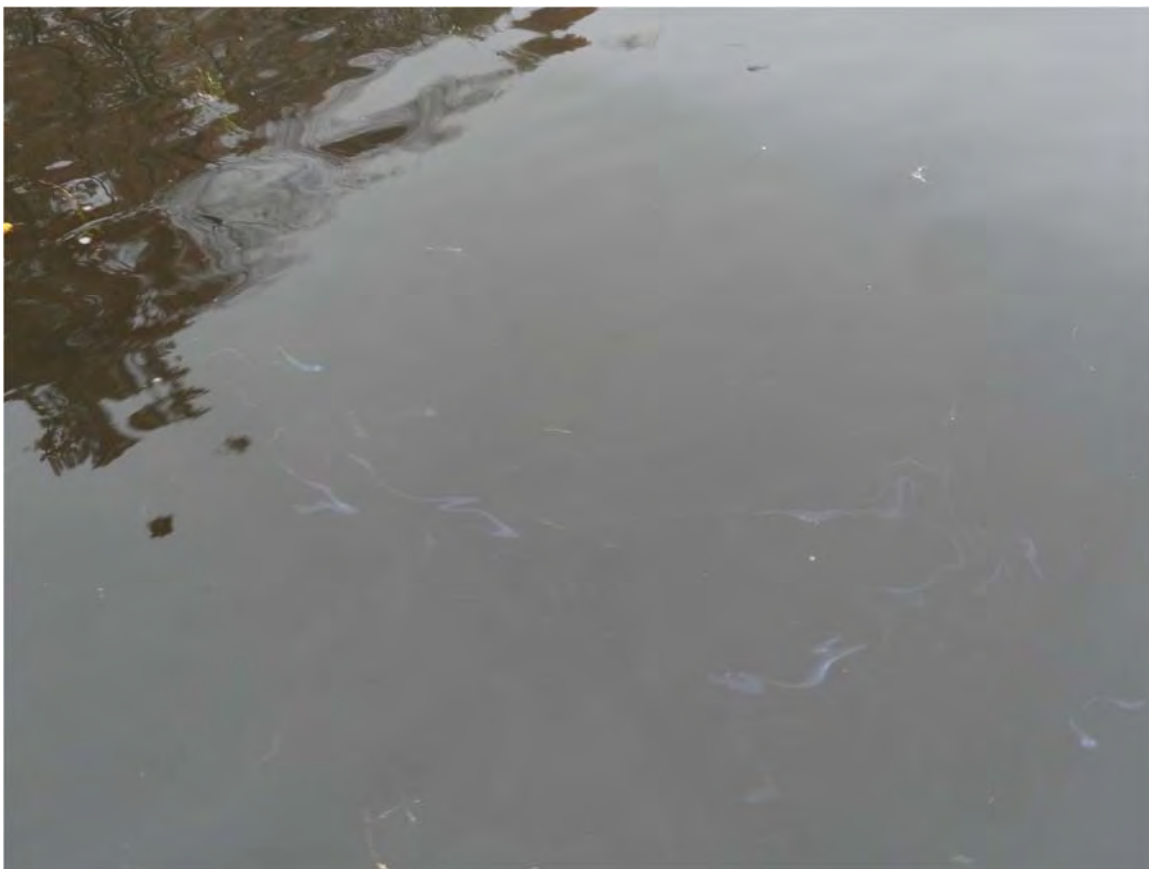
24. MP4.75 LDB sheen and tar globs observed.

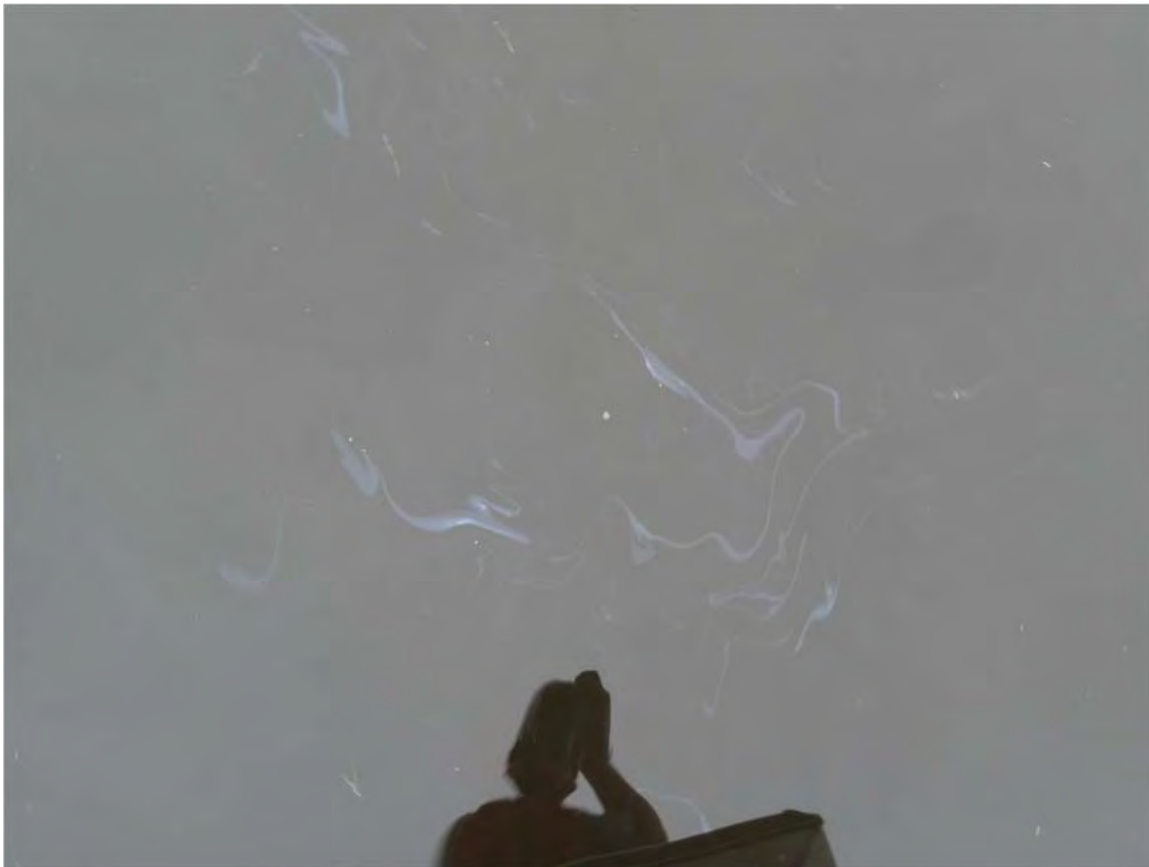
25. MP4.75 LDB sheen and tar globs observed.

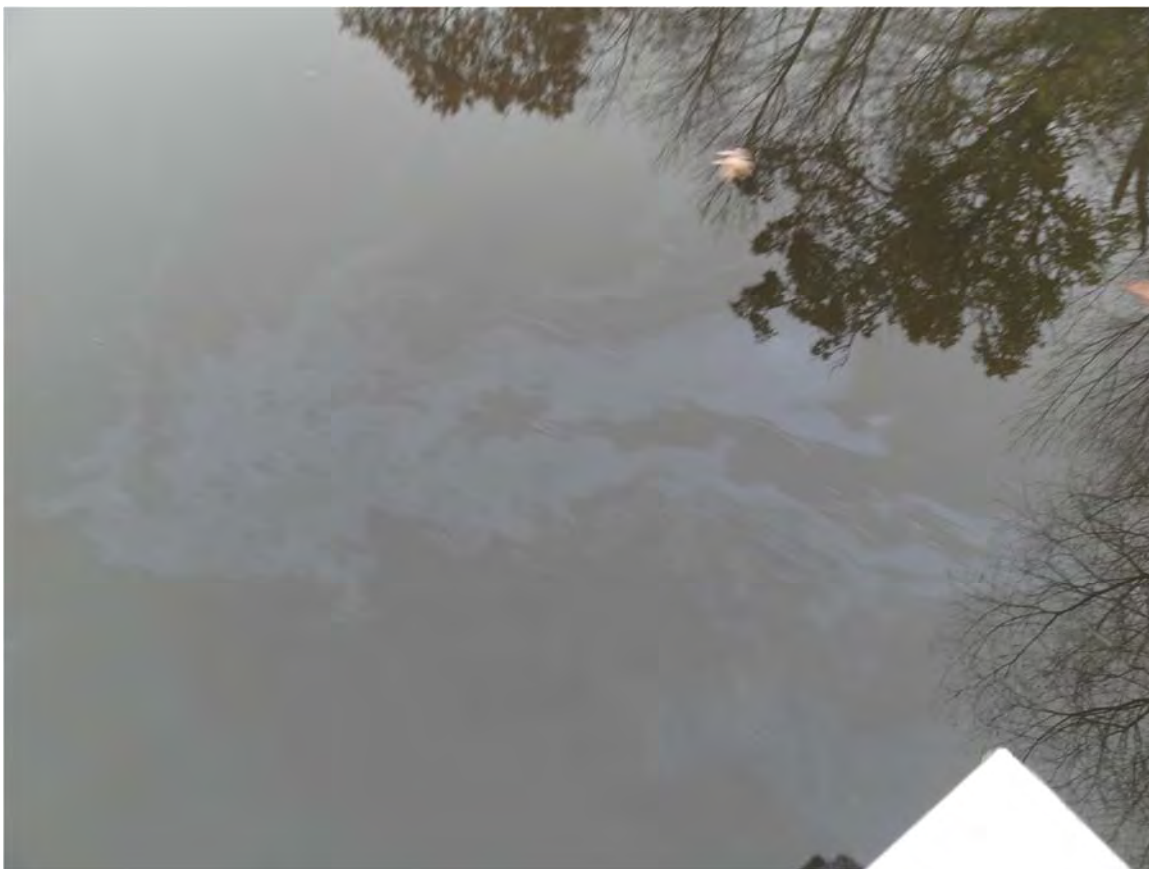
26. MP4.75 LDB sheen and tar globs observed.

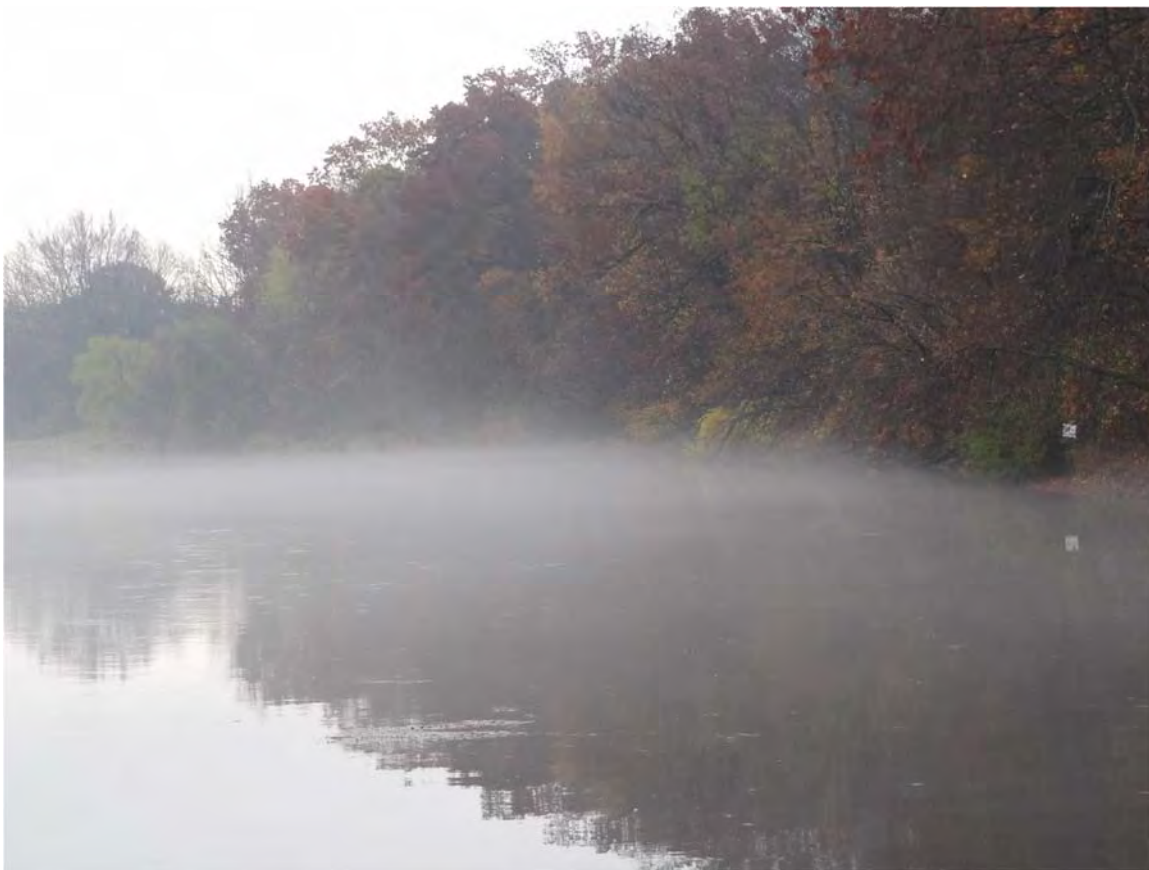
27. MP4.65 LDB Area where sheen and tar globs were observed.

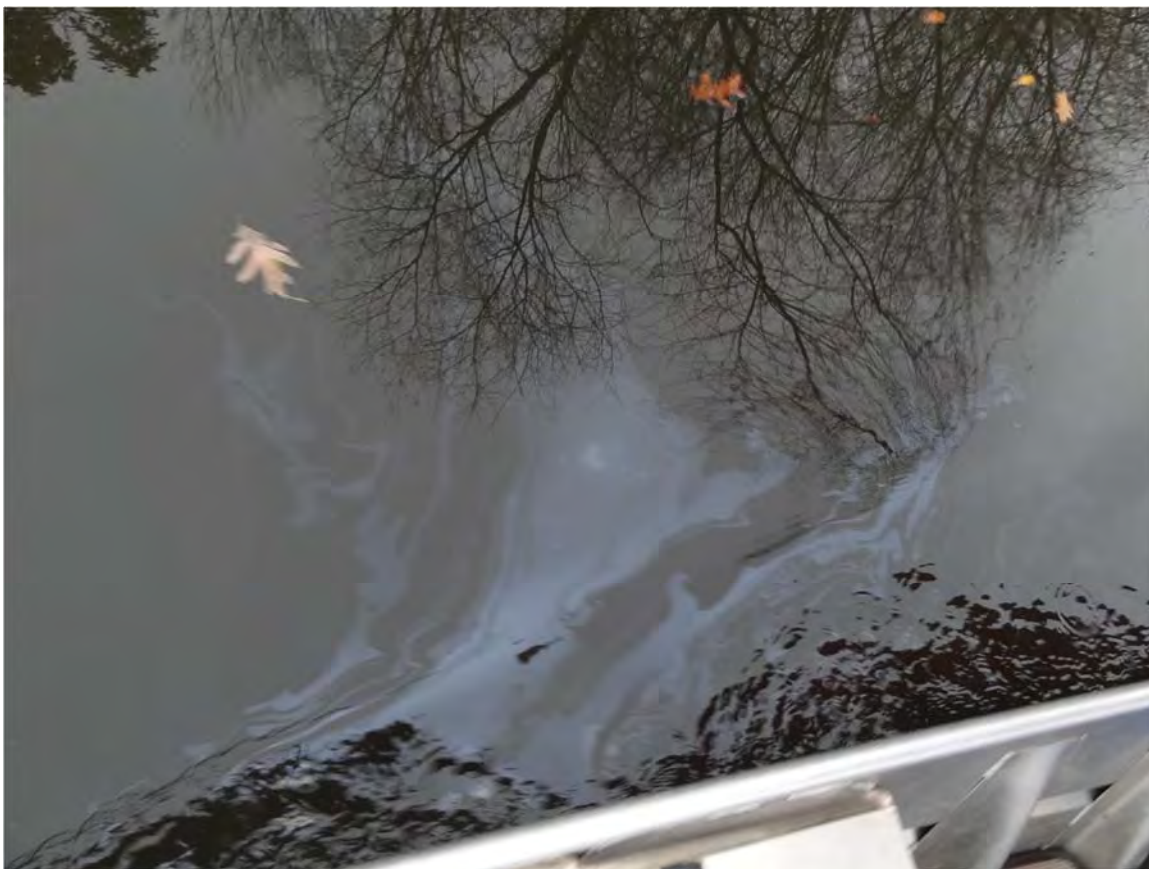
28. MP4.65 LDB sheen and tar globs observed.

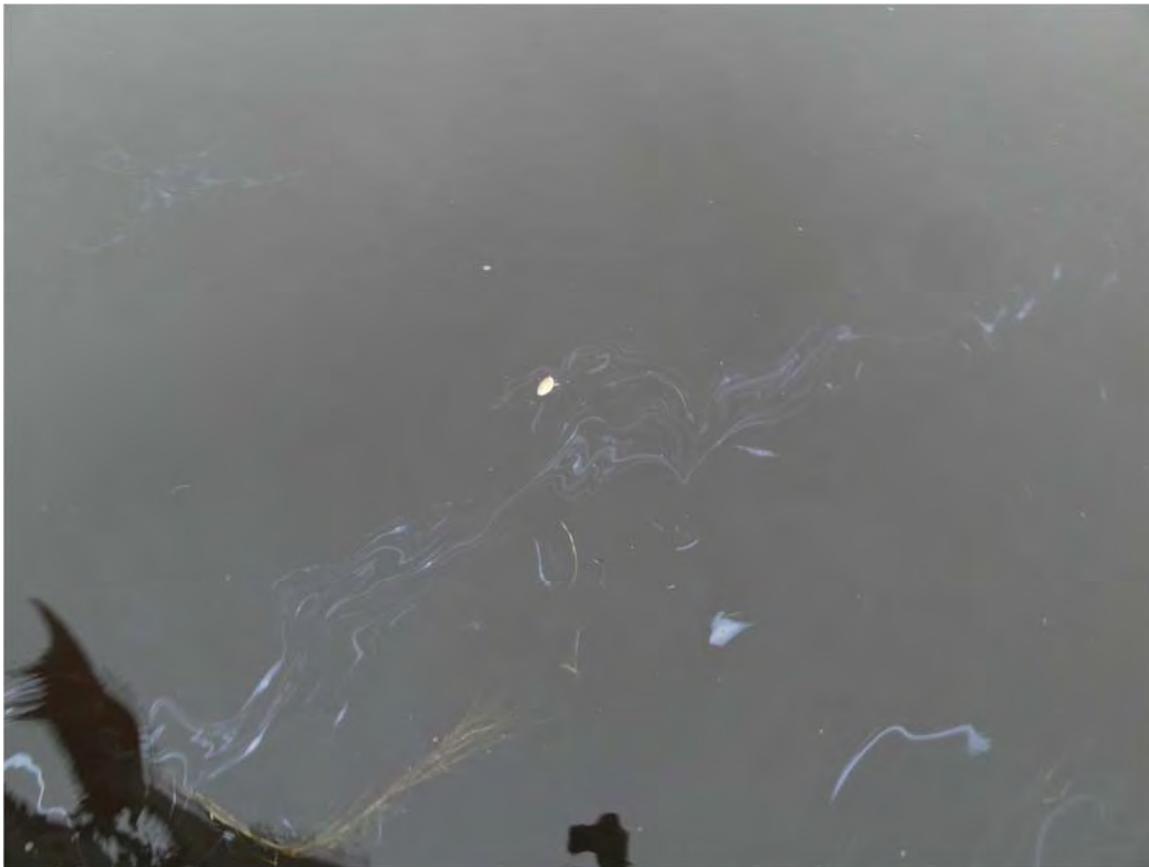
29. MP4.65 LDB sheen and tar globs observed.

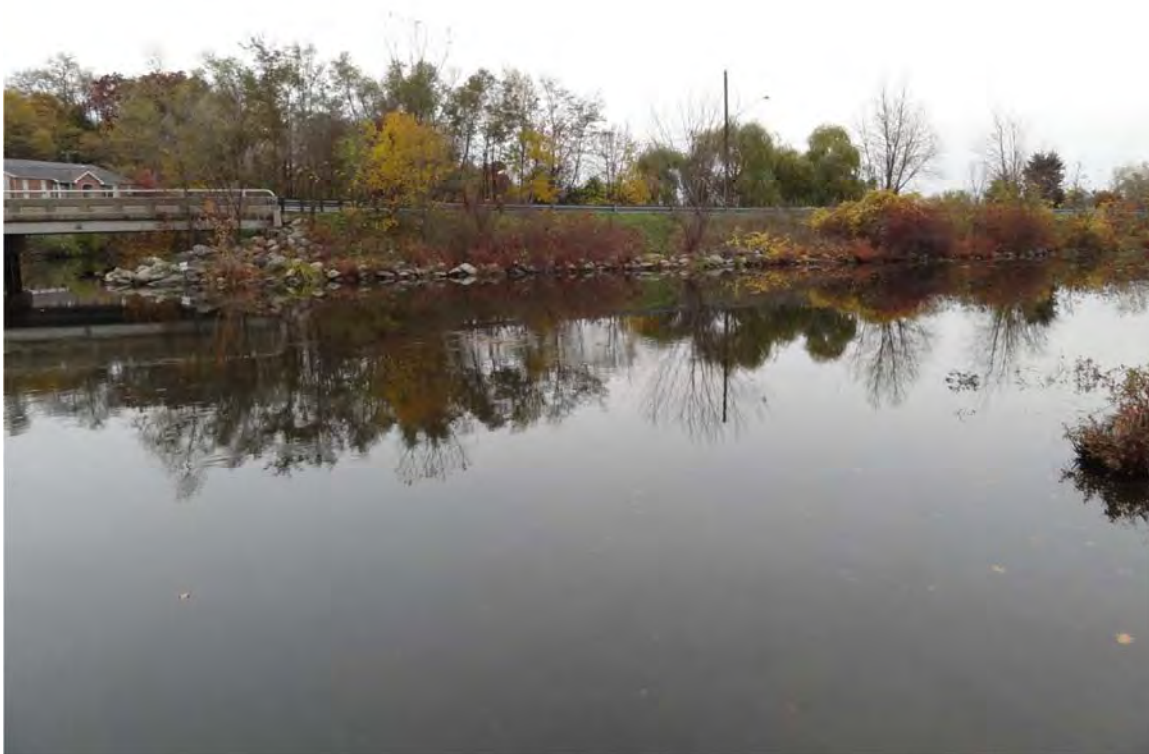
30. MP15.5 South Mill Pond sheen observed.

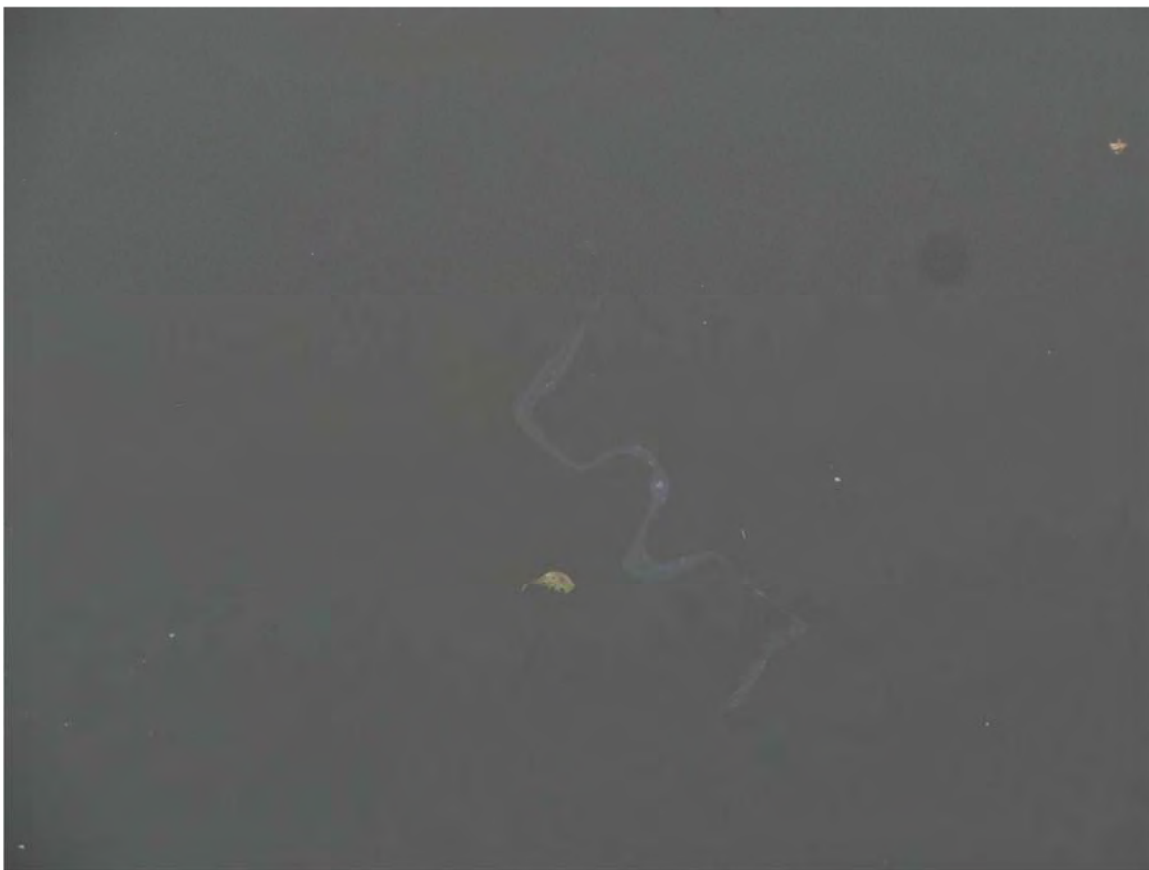
31. MP15.5 South Mill Pond sheen observed.

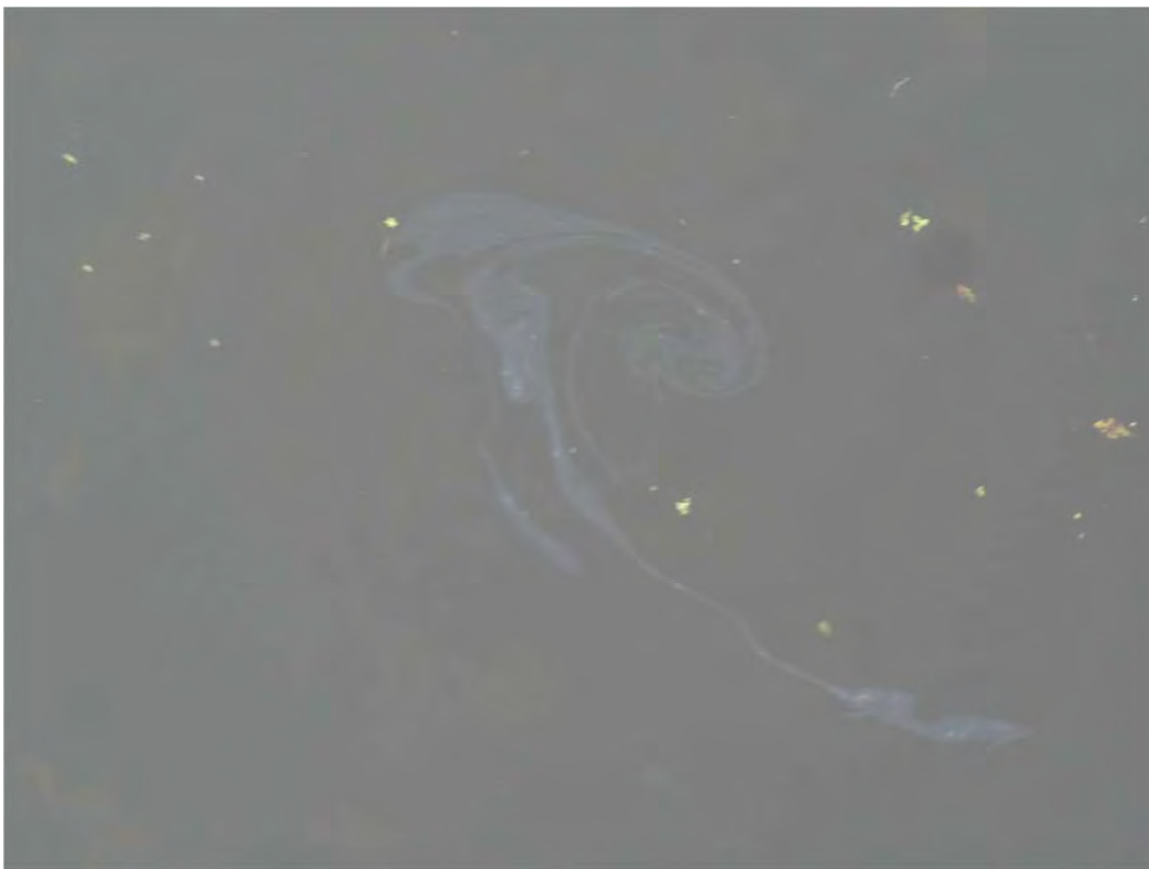
32. MP15.65 RDB North Mill Pond sheen observed in the river channel.

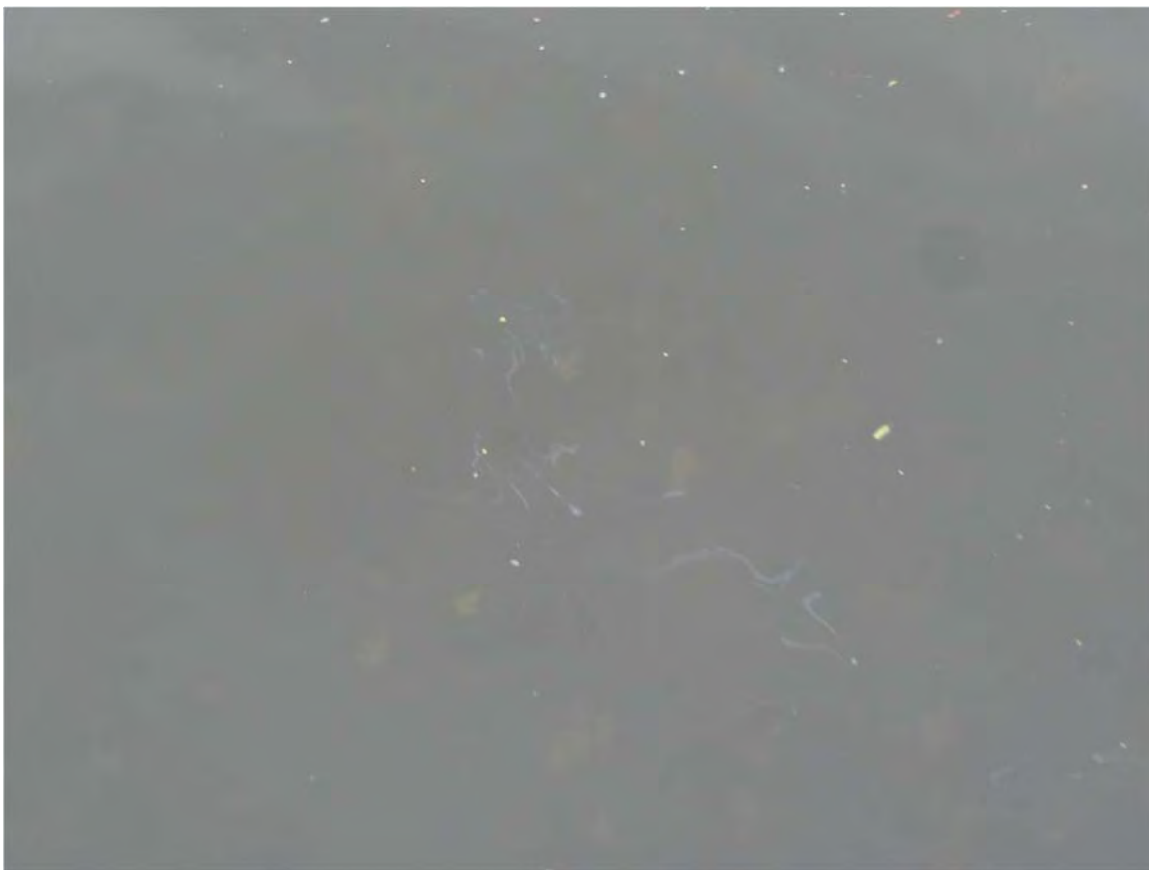
33. MP15.65 RDB North Mill Pond sheen observed in the river channel.

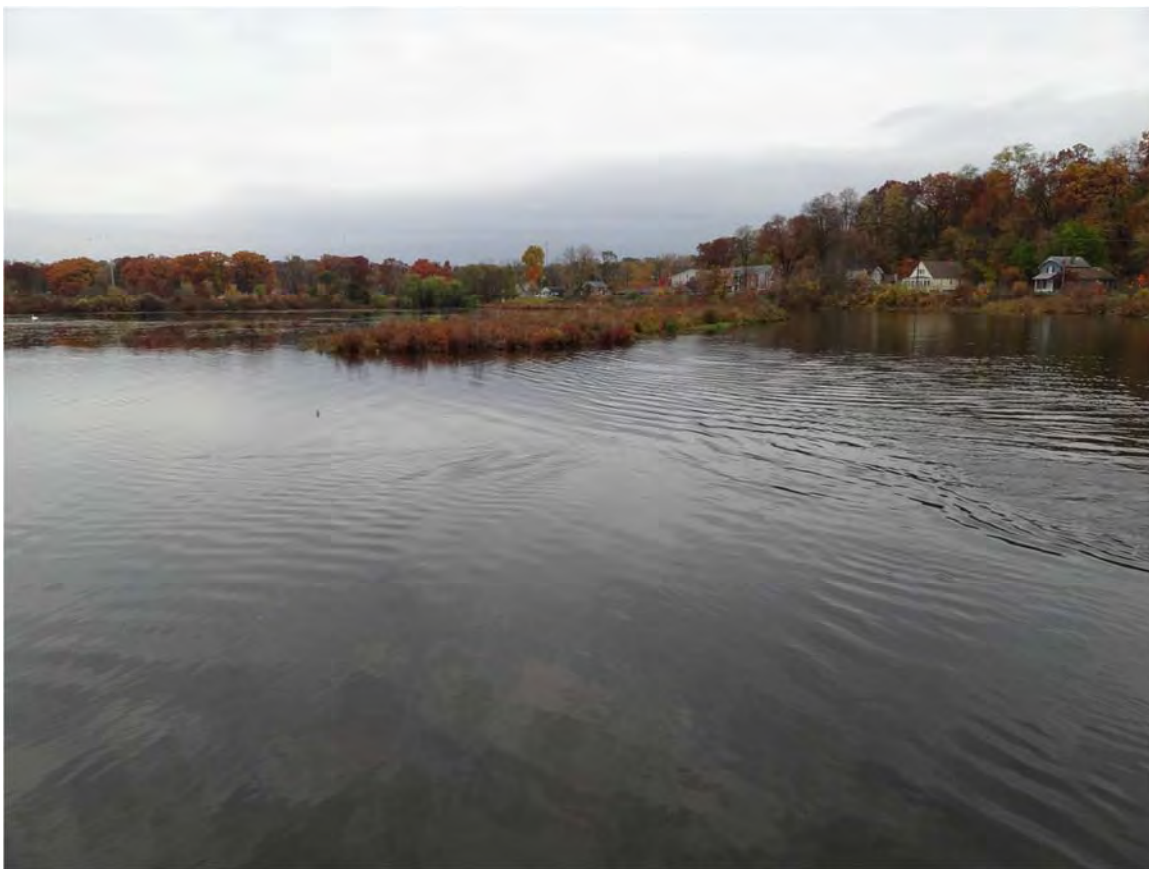
34. MP15.75 North Mill Pond area were sheen was observed accumulating.

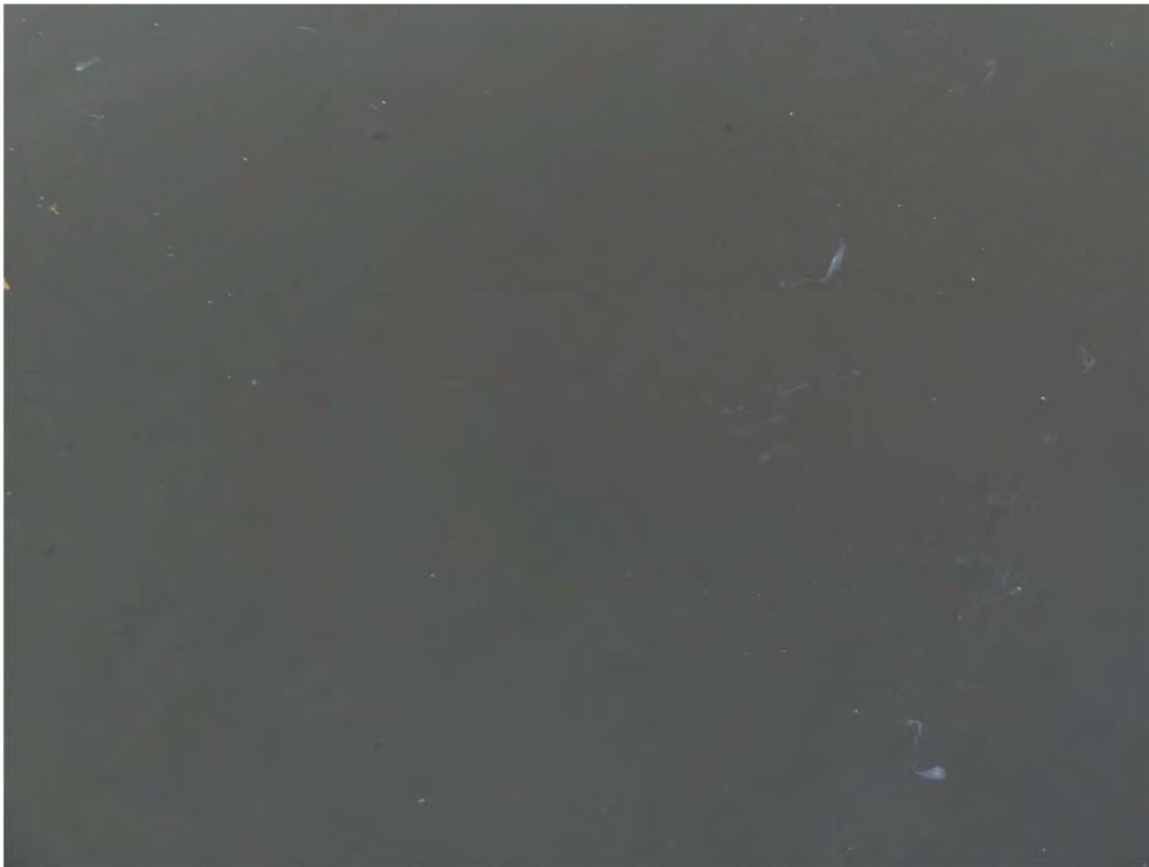
35. MP15.75 RDB North Mill Pond sheen was observed accumulating.

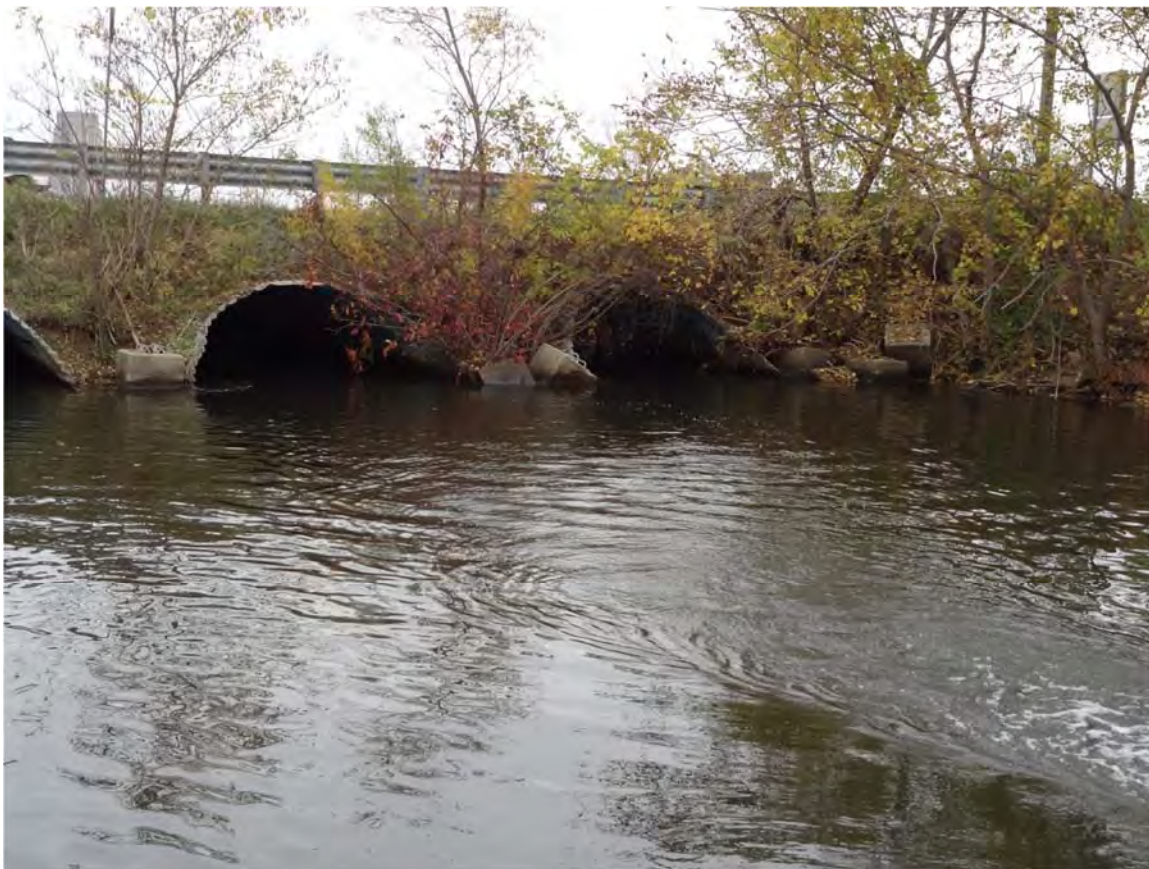
36. MP15.75 North Mill Pond area wher sheen was observed accumulating.

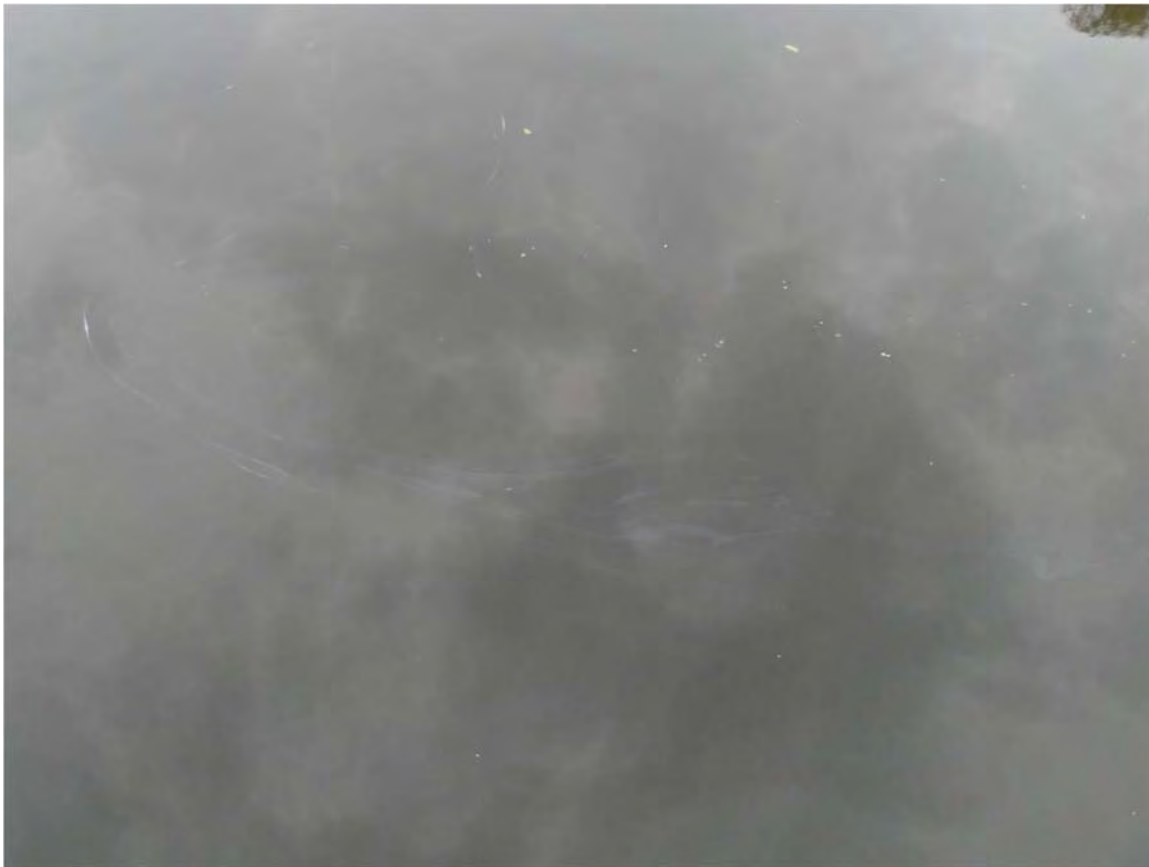
37. MP15.75 RDB North Mill Pond sheen was observed accumulating.

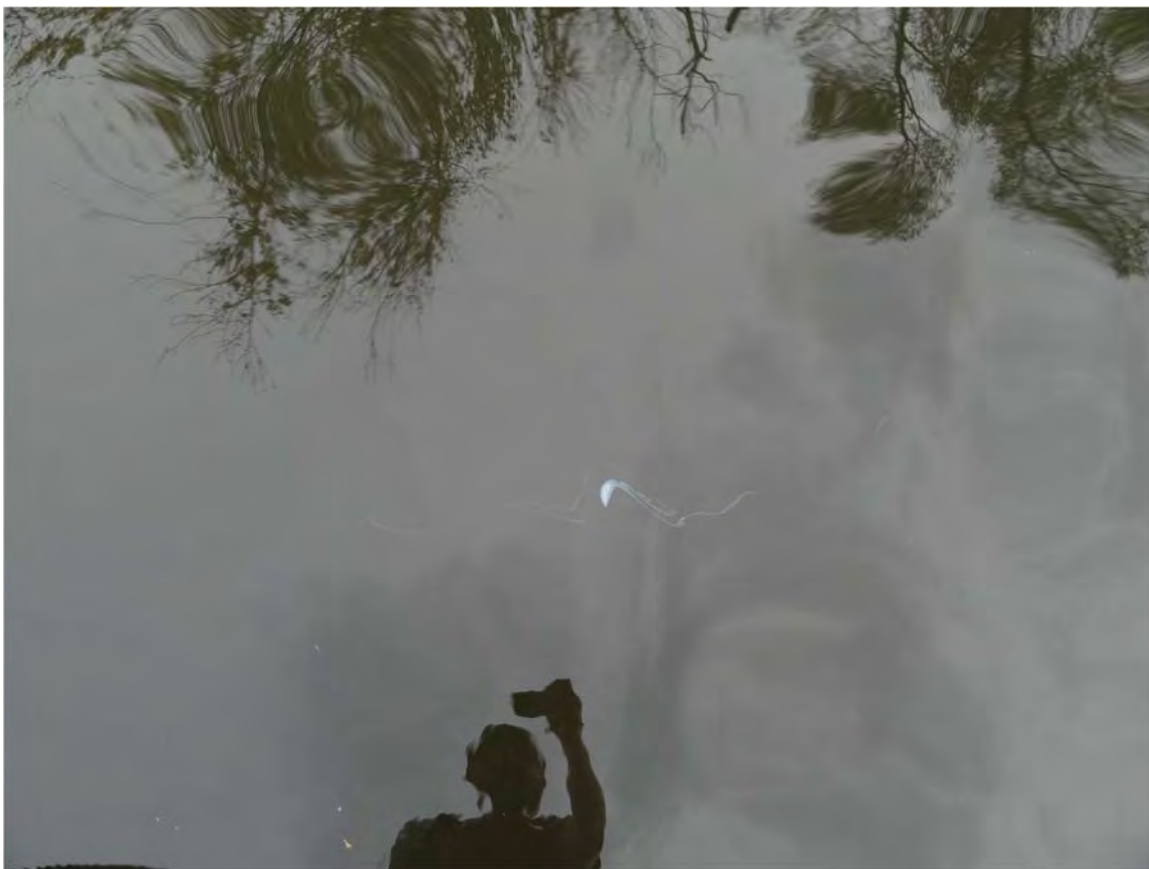
38. MP15.75 RDB North Mill Pond sheen was observed accumulating.

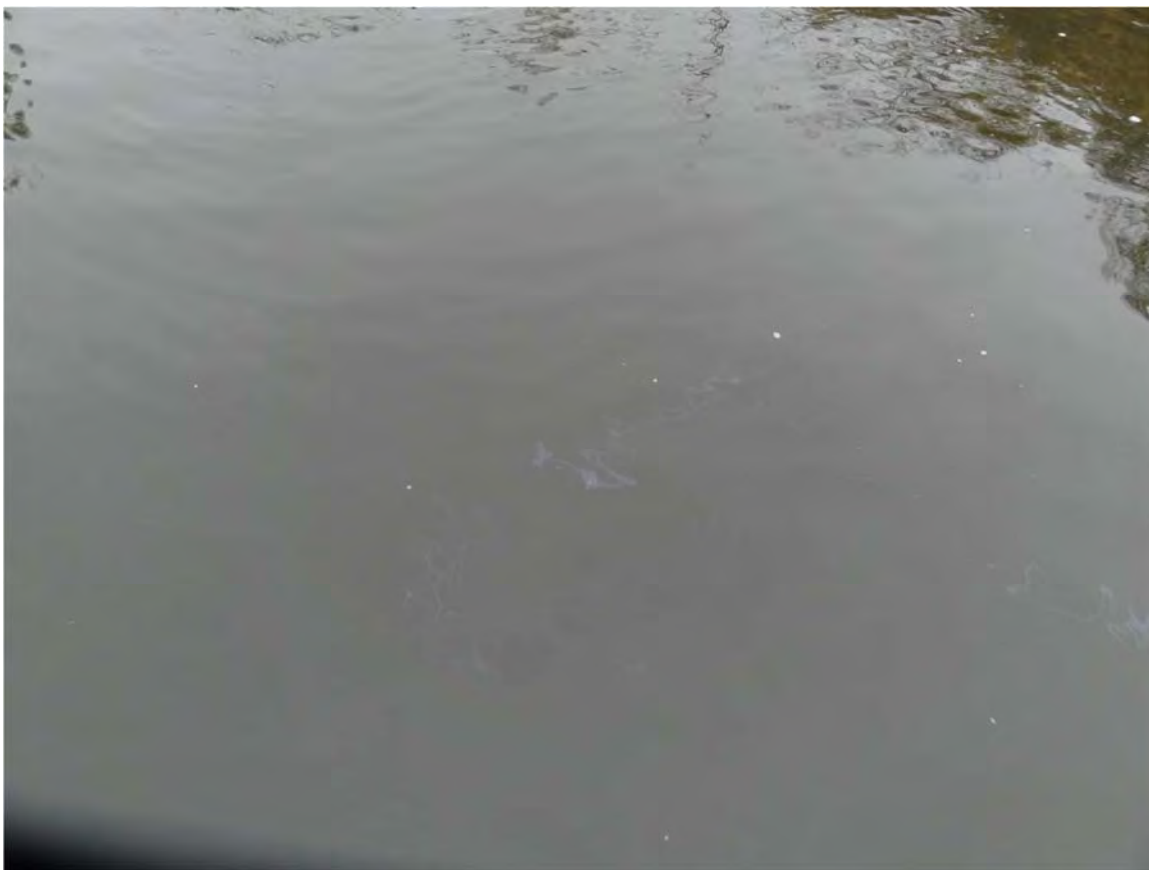
39. MP15.75 LDB North Mill Pond sheen observed.

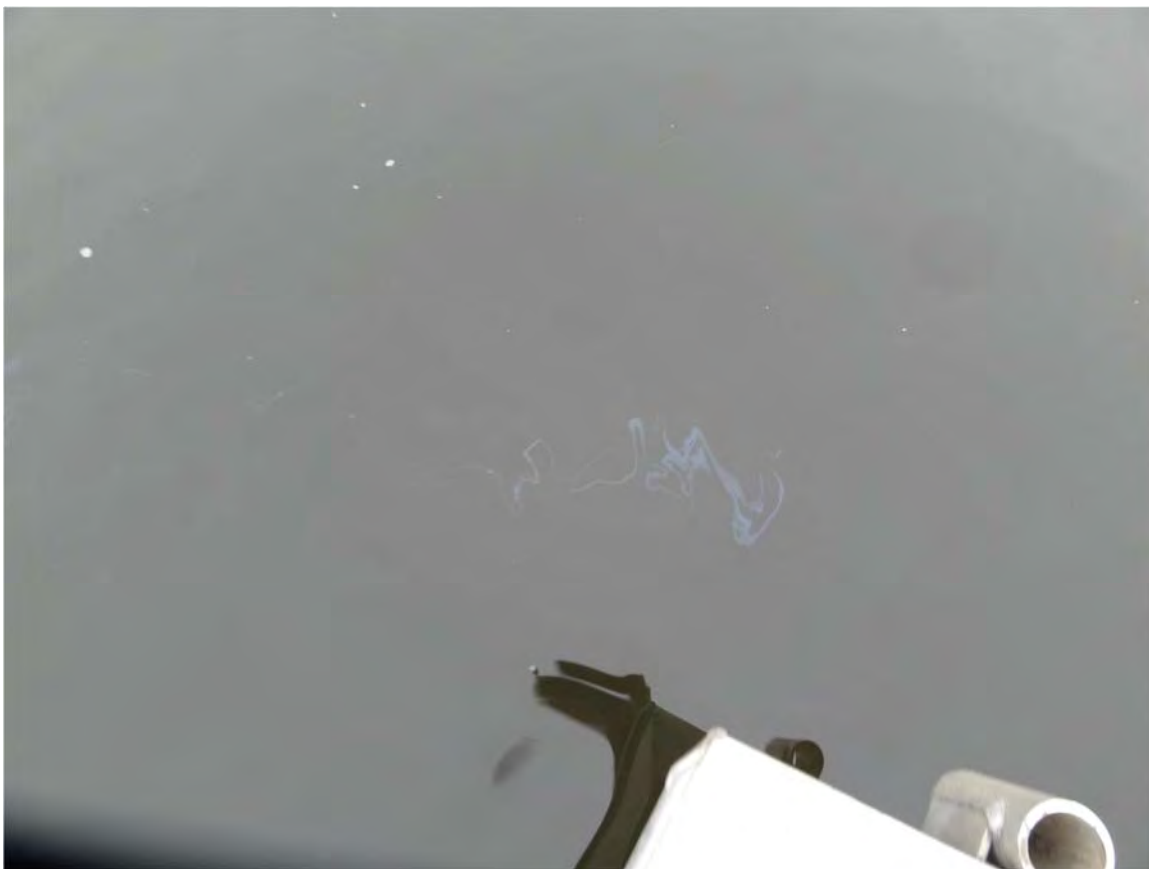
40. MP15.75 LDB North Mill Pond sheen observed.

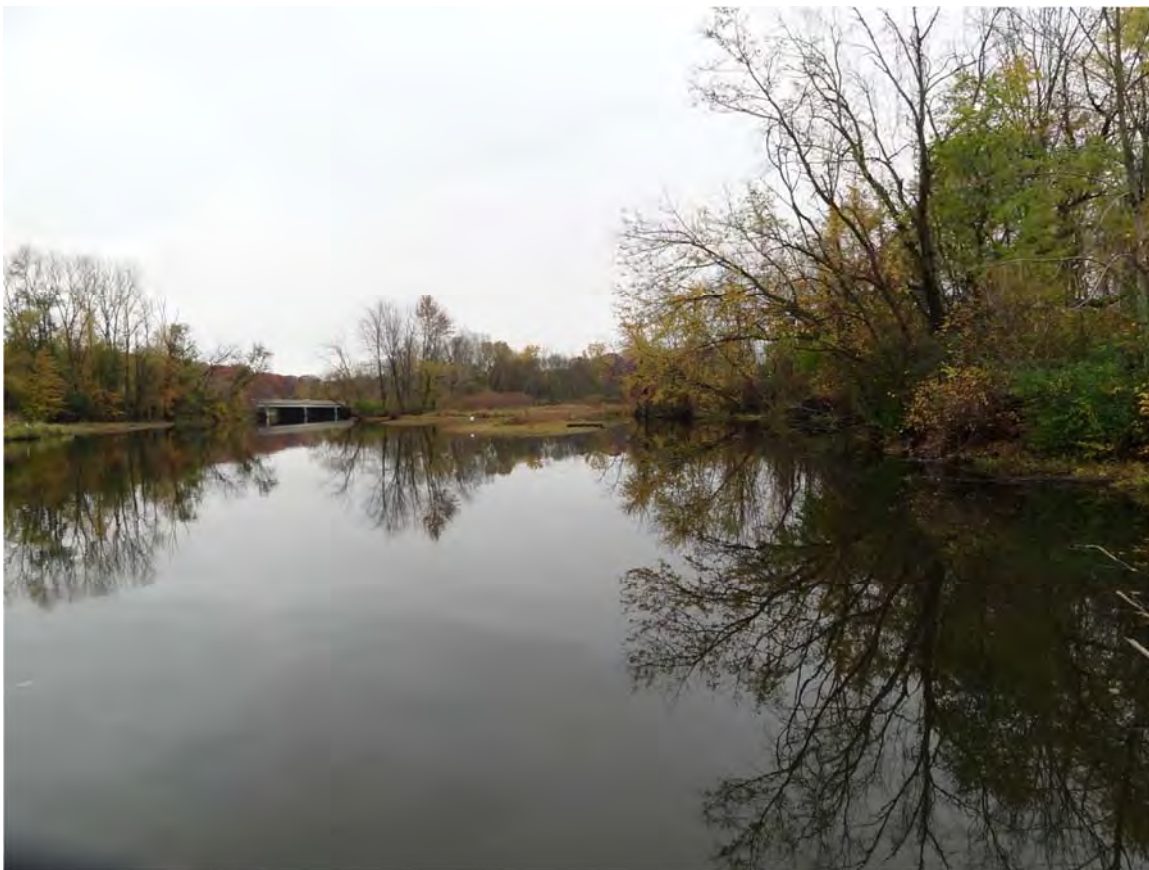
41. MP15.0 LDB area where sheen and tar globs where observed.

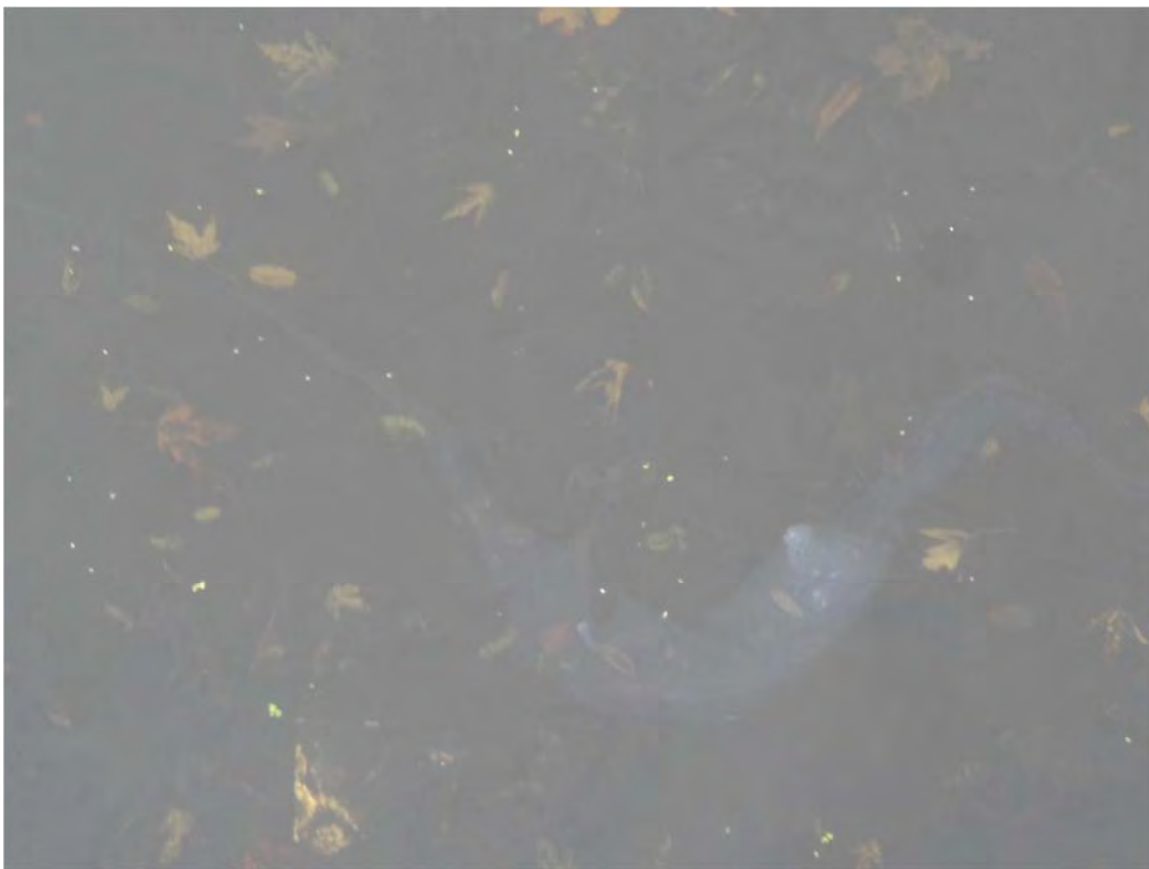
42. MP15.0 LDB sheen and tar globs observed.

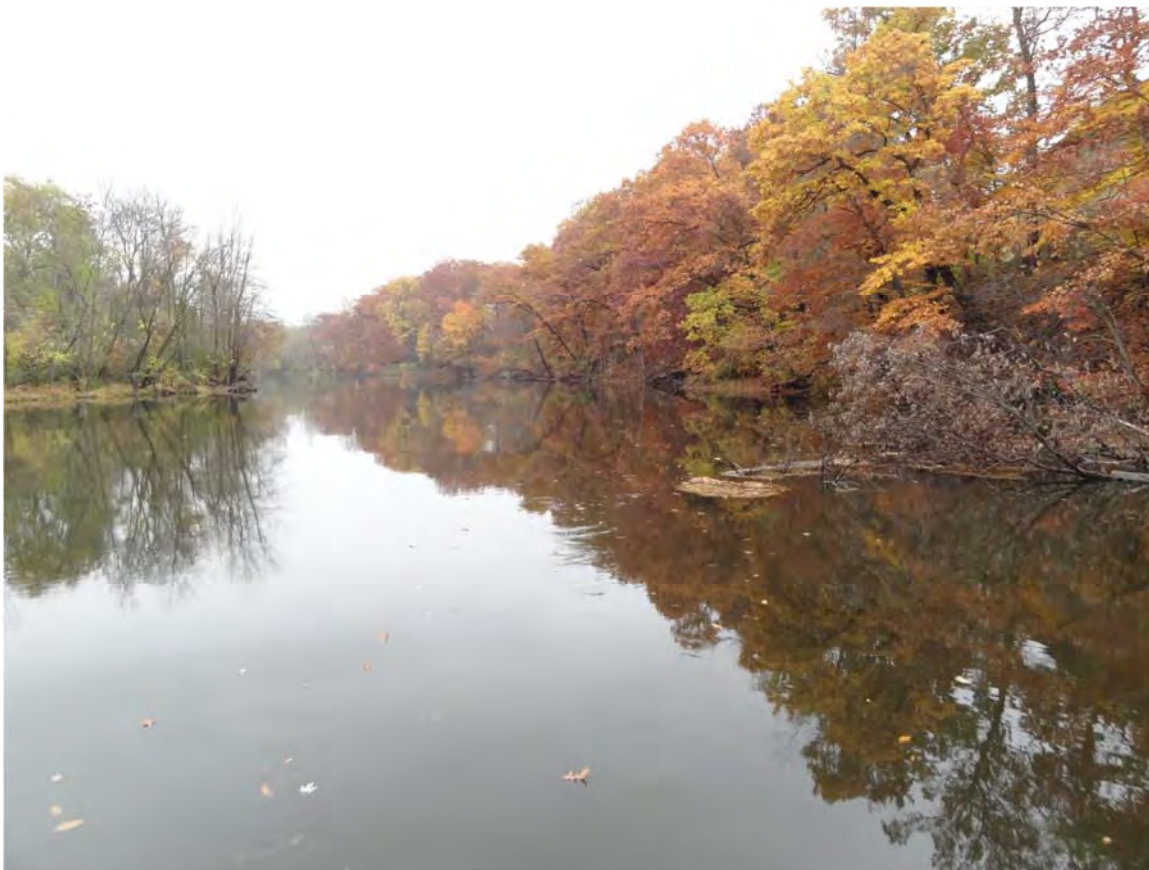
43. MP14.75 LDB area where sheen and tar globs observed.

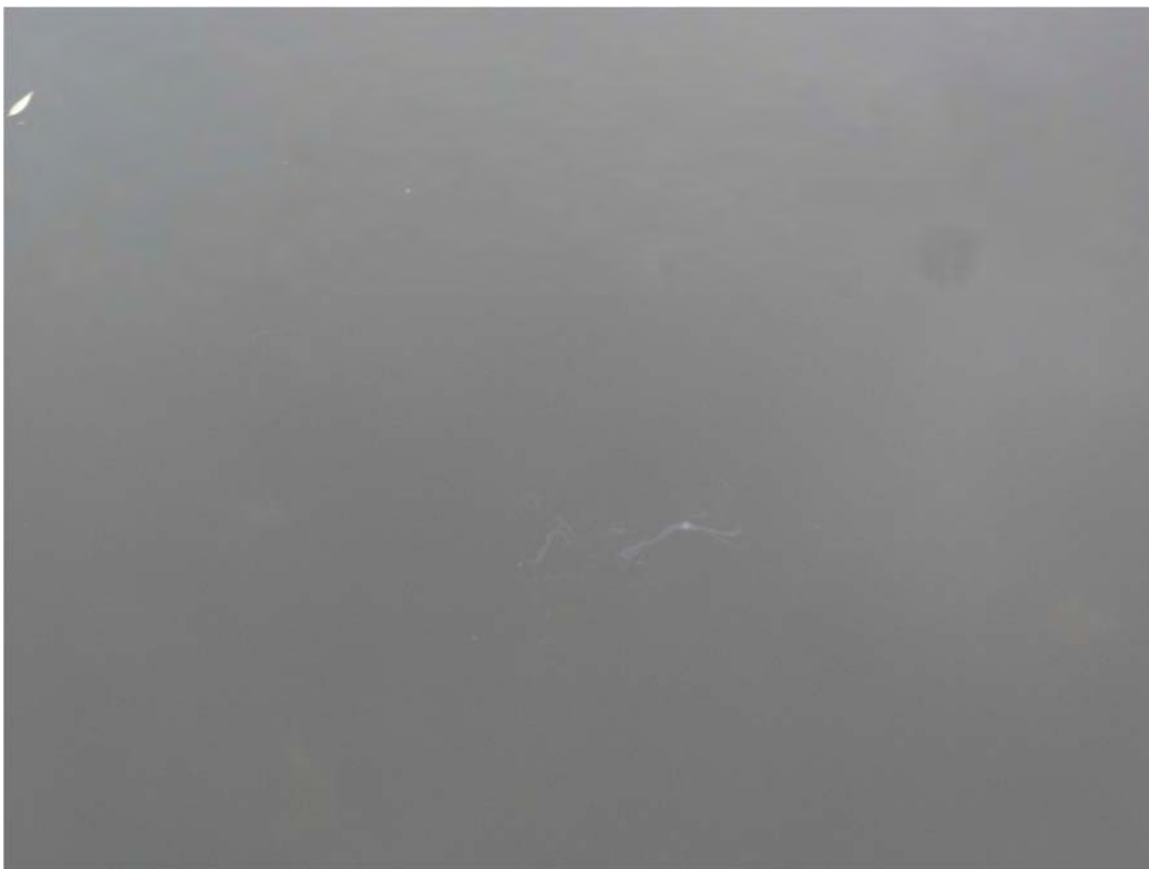
44. MP14.75 LDB sheen and tar globs observed.

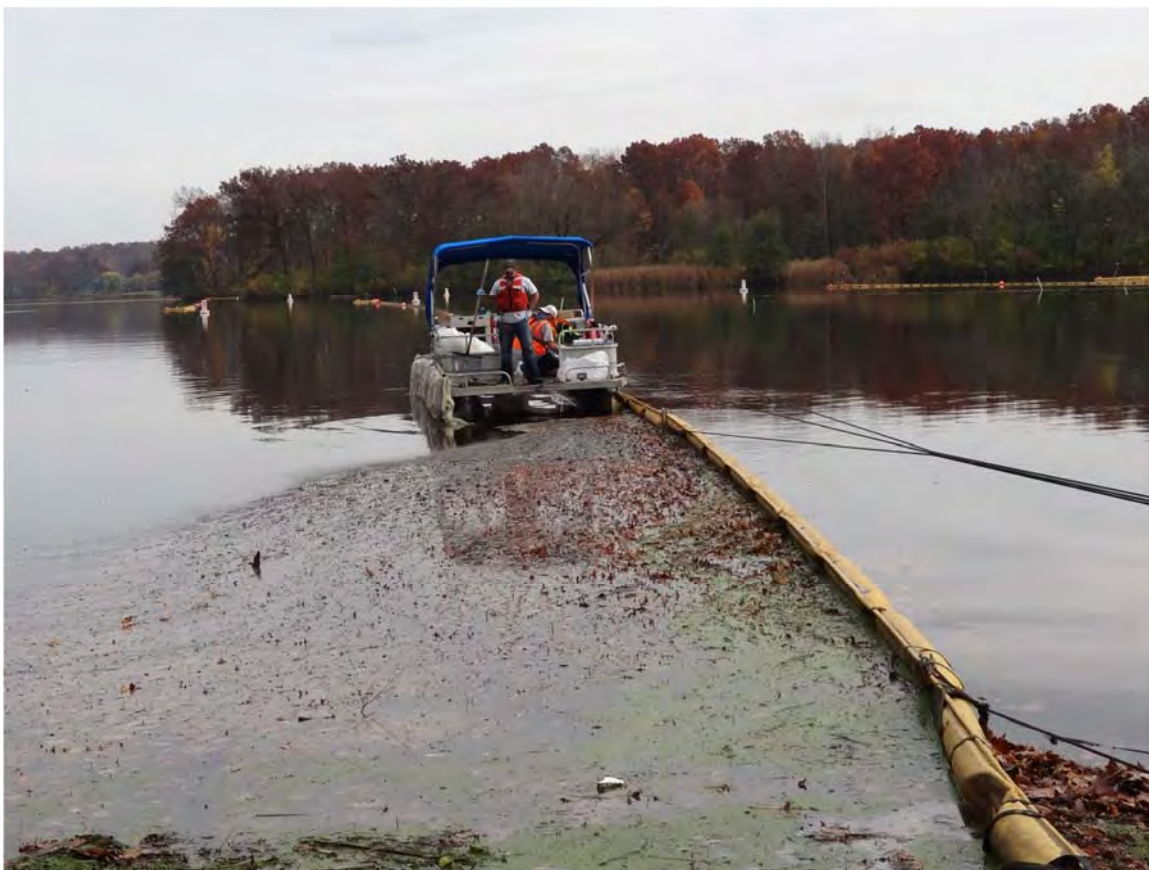
45. Morrow Lake Delta Gate E observed a crew removing debris from the control point boom.

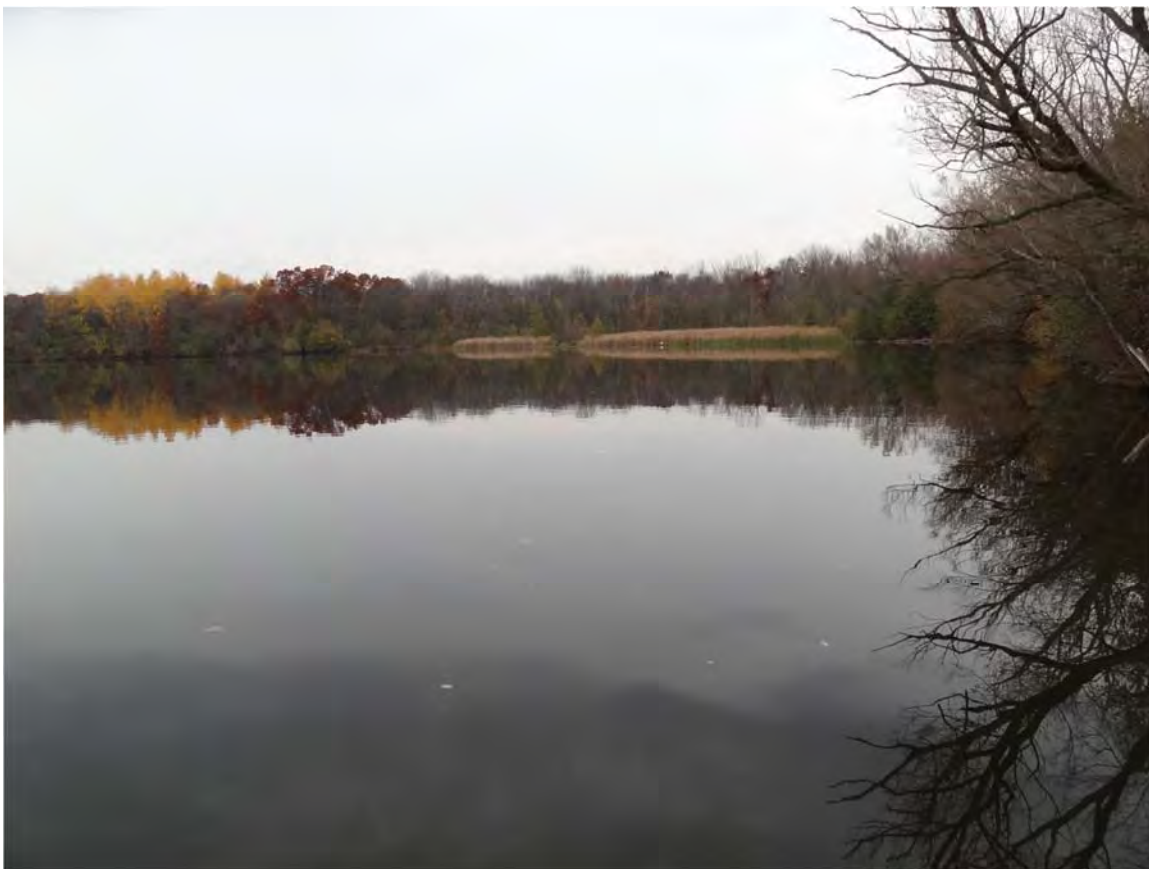
46. Morrow Lake North Cove sheen and tar globs observed.
